UNDERWATER BRIDGE INSPECTION REPORT

STRUCTURE NO. 6391

MINNESOTA RIVER

PREPARED FOR THE
MINNESOTA DEPARTMENT OF TRANSPORTATION
BY
COLLINS ENGINEERS, INC.
JOB NO. 5221 (CEI 91)

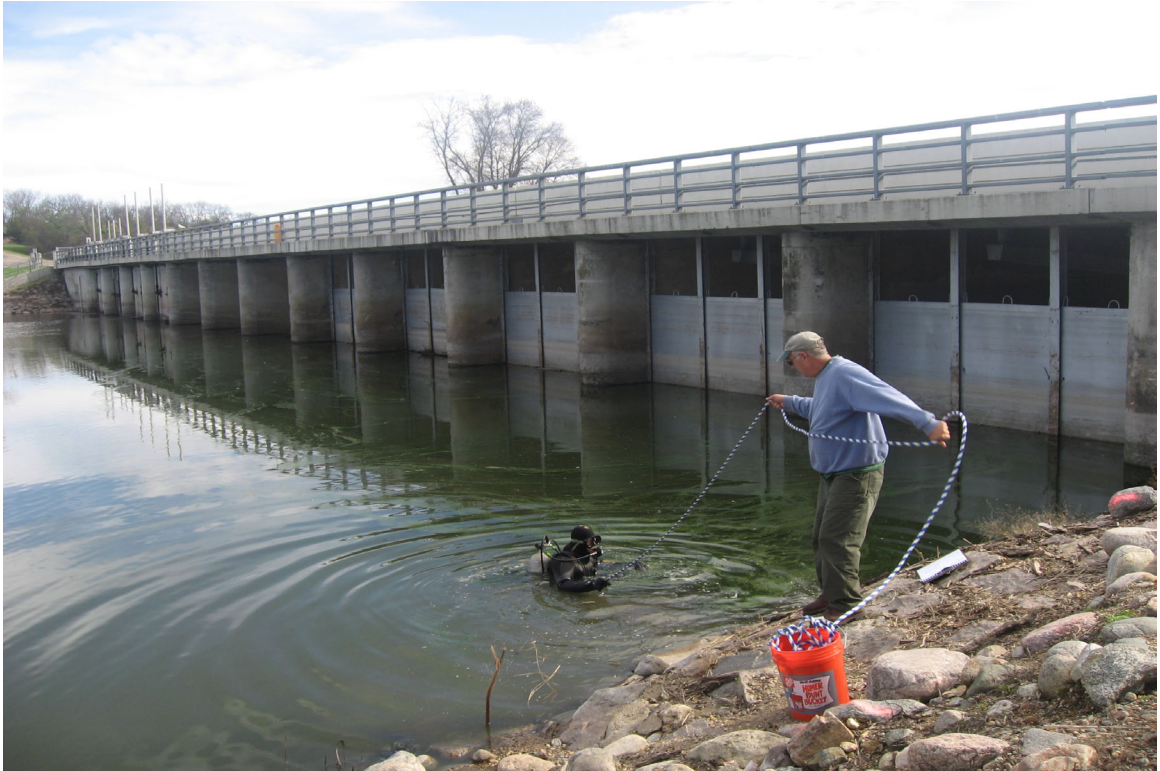
Photograph 1. Overall View of the Structure, Looking Southeast.

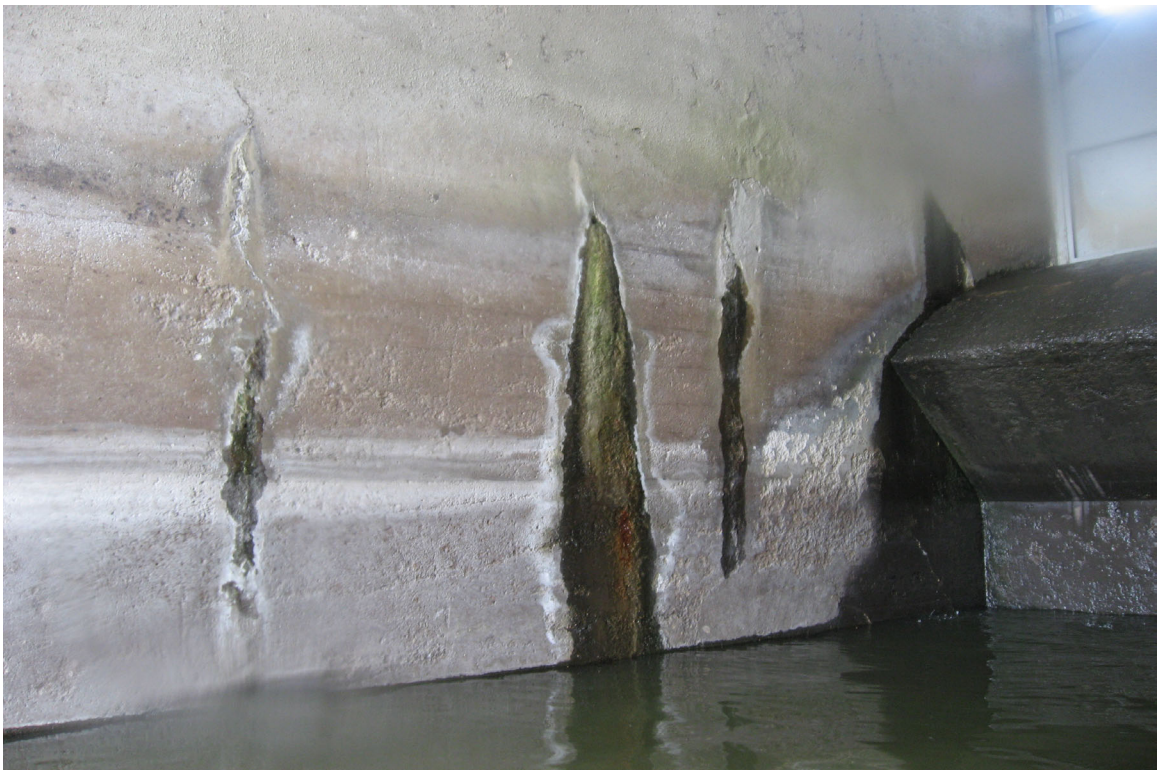
Photograph 2. View of the West Abutment Wall, Looking Northwest.

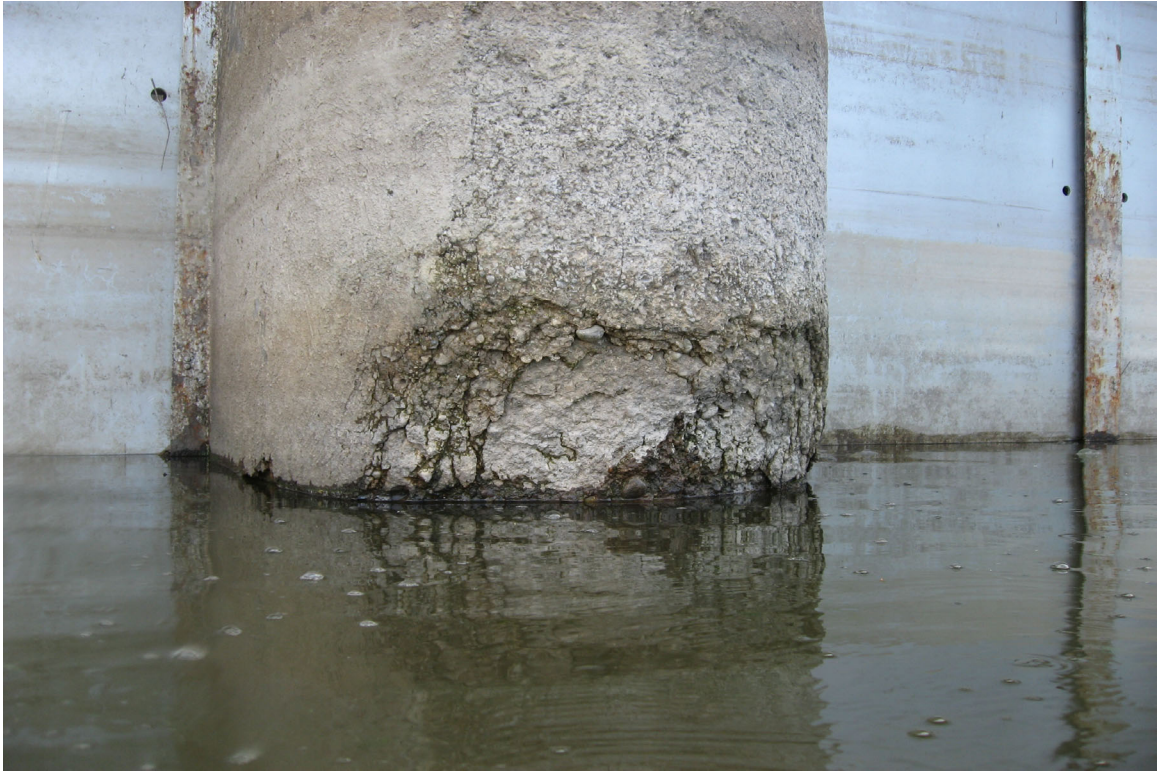
- (A) There was moderate to heavy scaling (related to ice damage) throughout most of the pier faces from 8 feet above the waterline to approximately 5 feet below the waterline. The scaling displayed penetrations of up to 3 inches with, in some cases, exposed reinforcing steel that exhibited less than 10% section loss.
- (B) Numerous spalls with exposed reinforcing steel that exhibited less than 10% section loss were observed at random locations on most of the piers.
- (C) Timber debris was observed scattered on the upstream channel bottom with pieces of drift up to 1 foot in diameter.

Photograph 3. View of the Upstream Nose of Pier 2, Looking Southwest. Note the Deteriorated Condition of the Concrete.

- (A) To prevent further, more detrimental deformations repair all areas of spalling or heavy scaling with exposed reinforcing steel with a concrete grout mix for underwater applications designed to provide high durability and low permeability.
- (B) Monitor the timber debris across the upstream fascia of the bridge, and if found to be increasing in the future, removal operations may become warranted.
- (C) Reinspect the submerged substructure units at the normal maximum recommended (NBIS) interval of five (5) years.

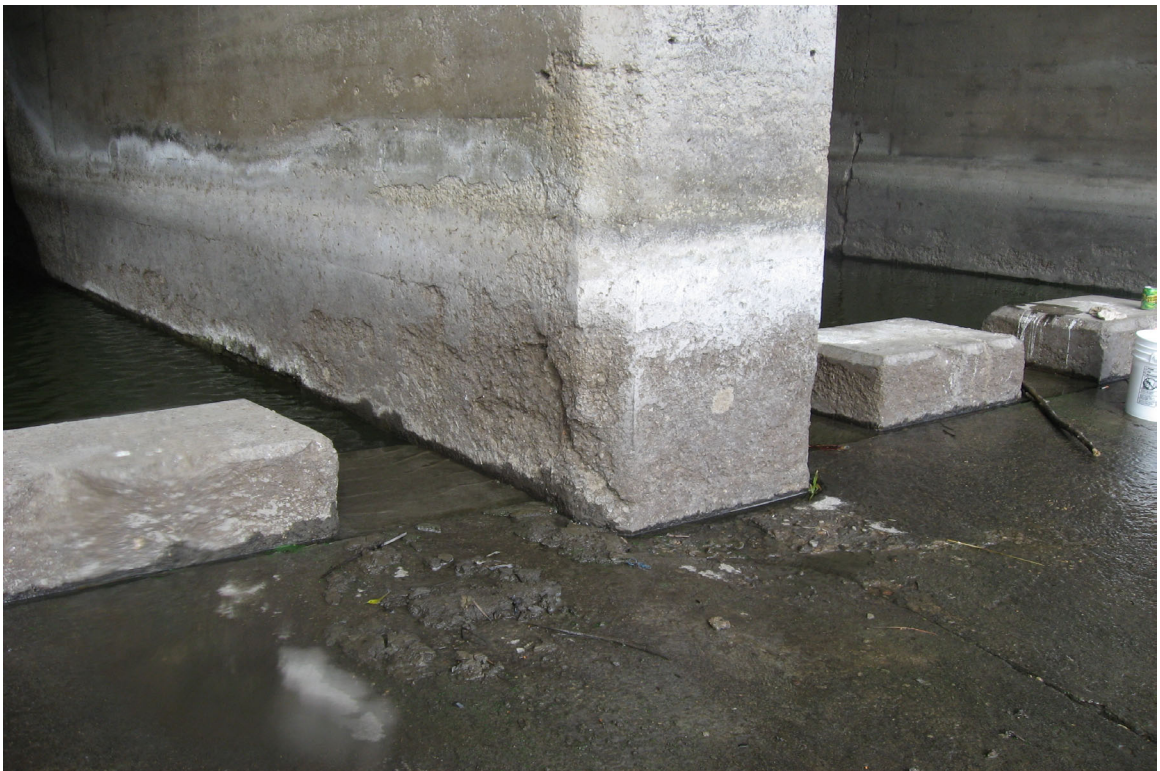
Photograph 4. View of the Downstream Nose of Pier 3, Looking Northeast.

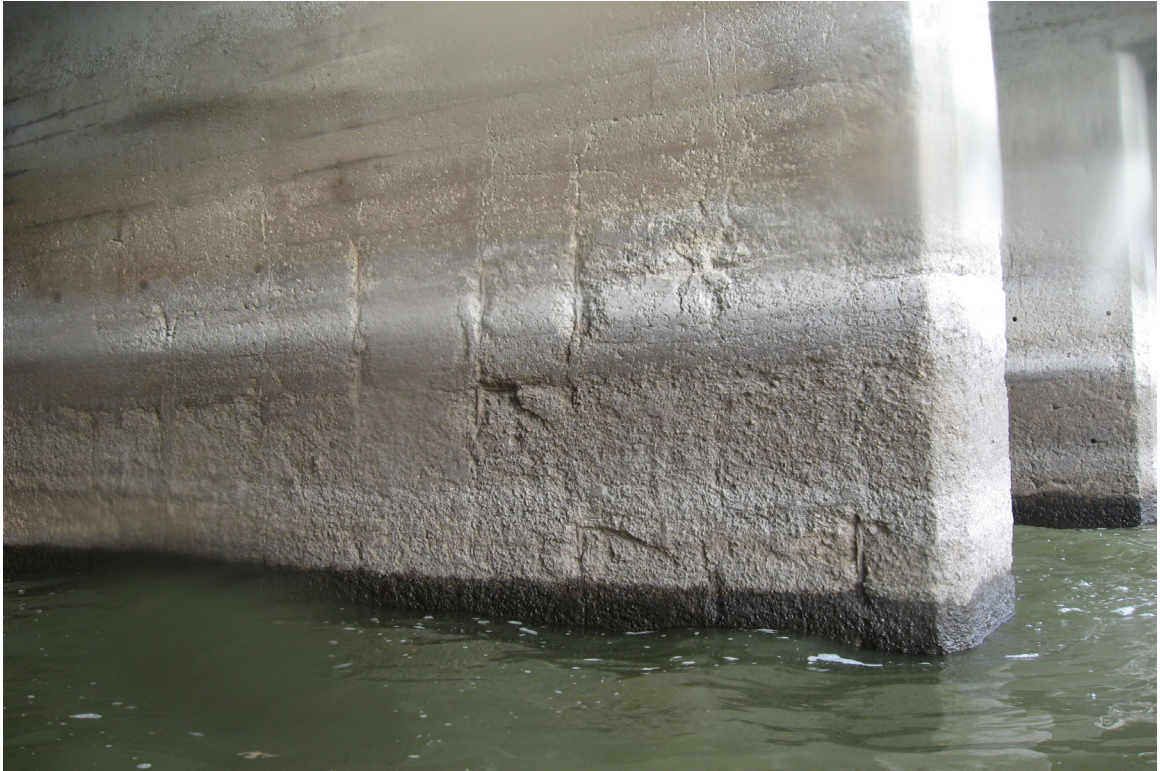
Photograph 5. View of Pier 5, Looking Northeast.

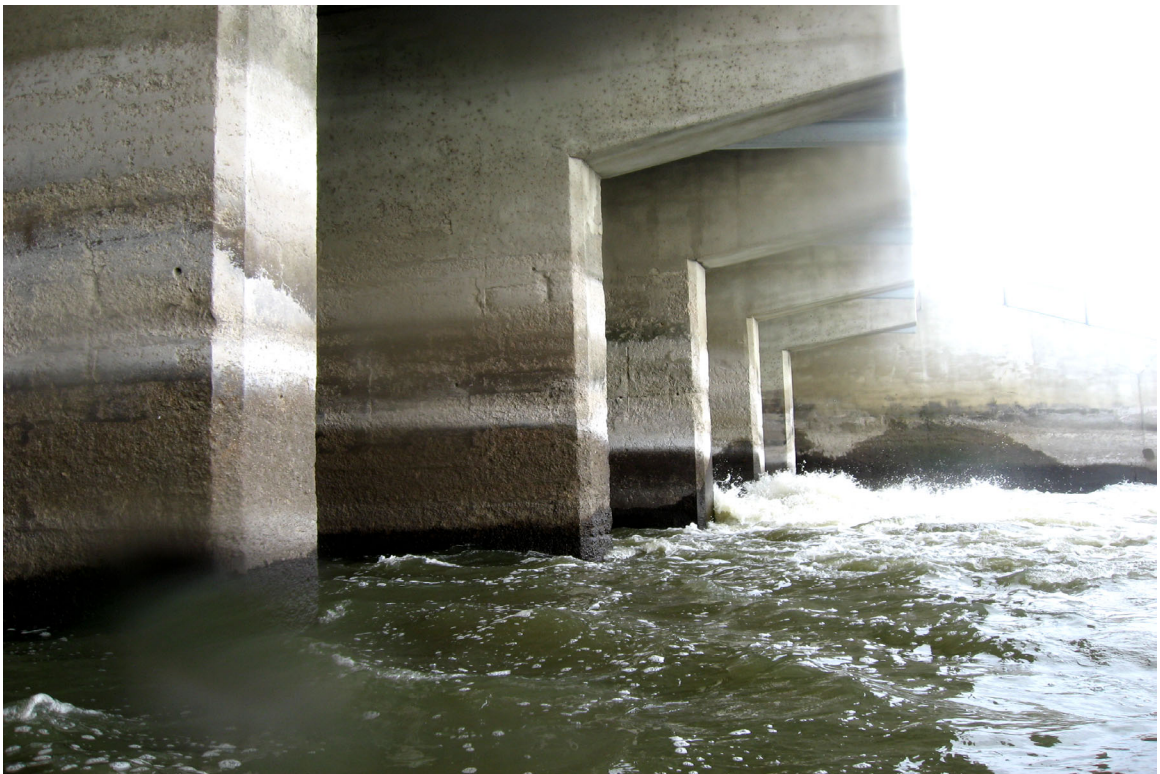
Photograph 6. View of Piers 7 through 11, Looking Northeast.

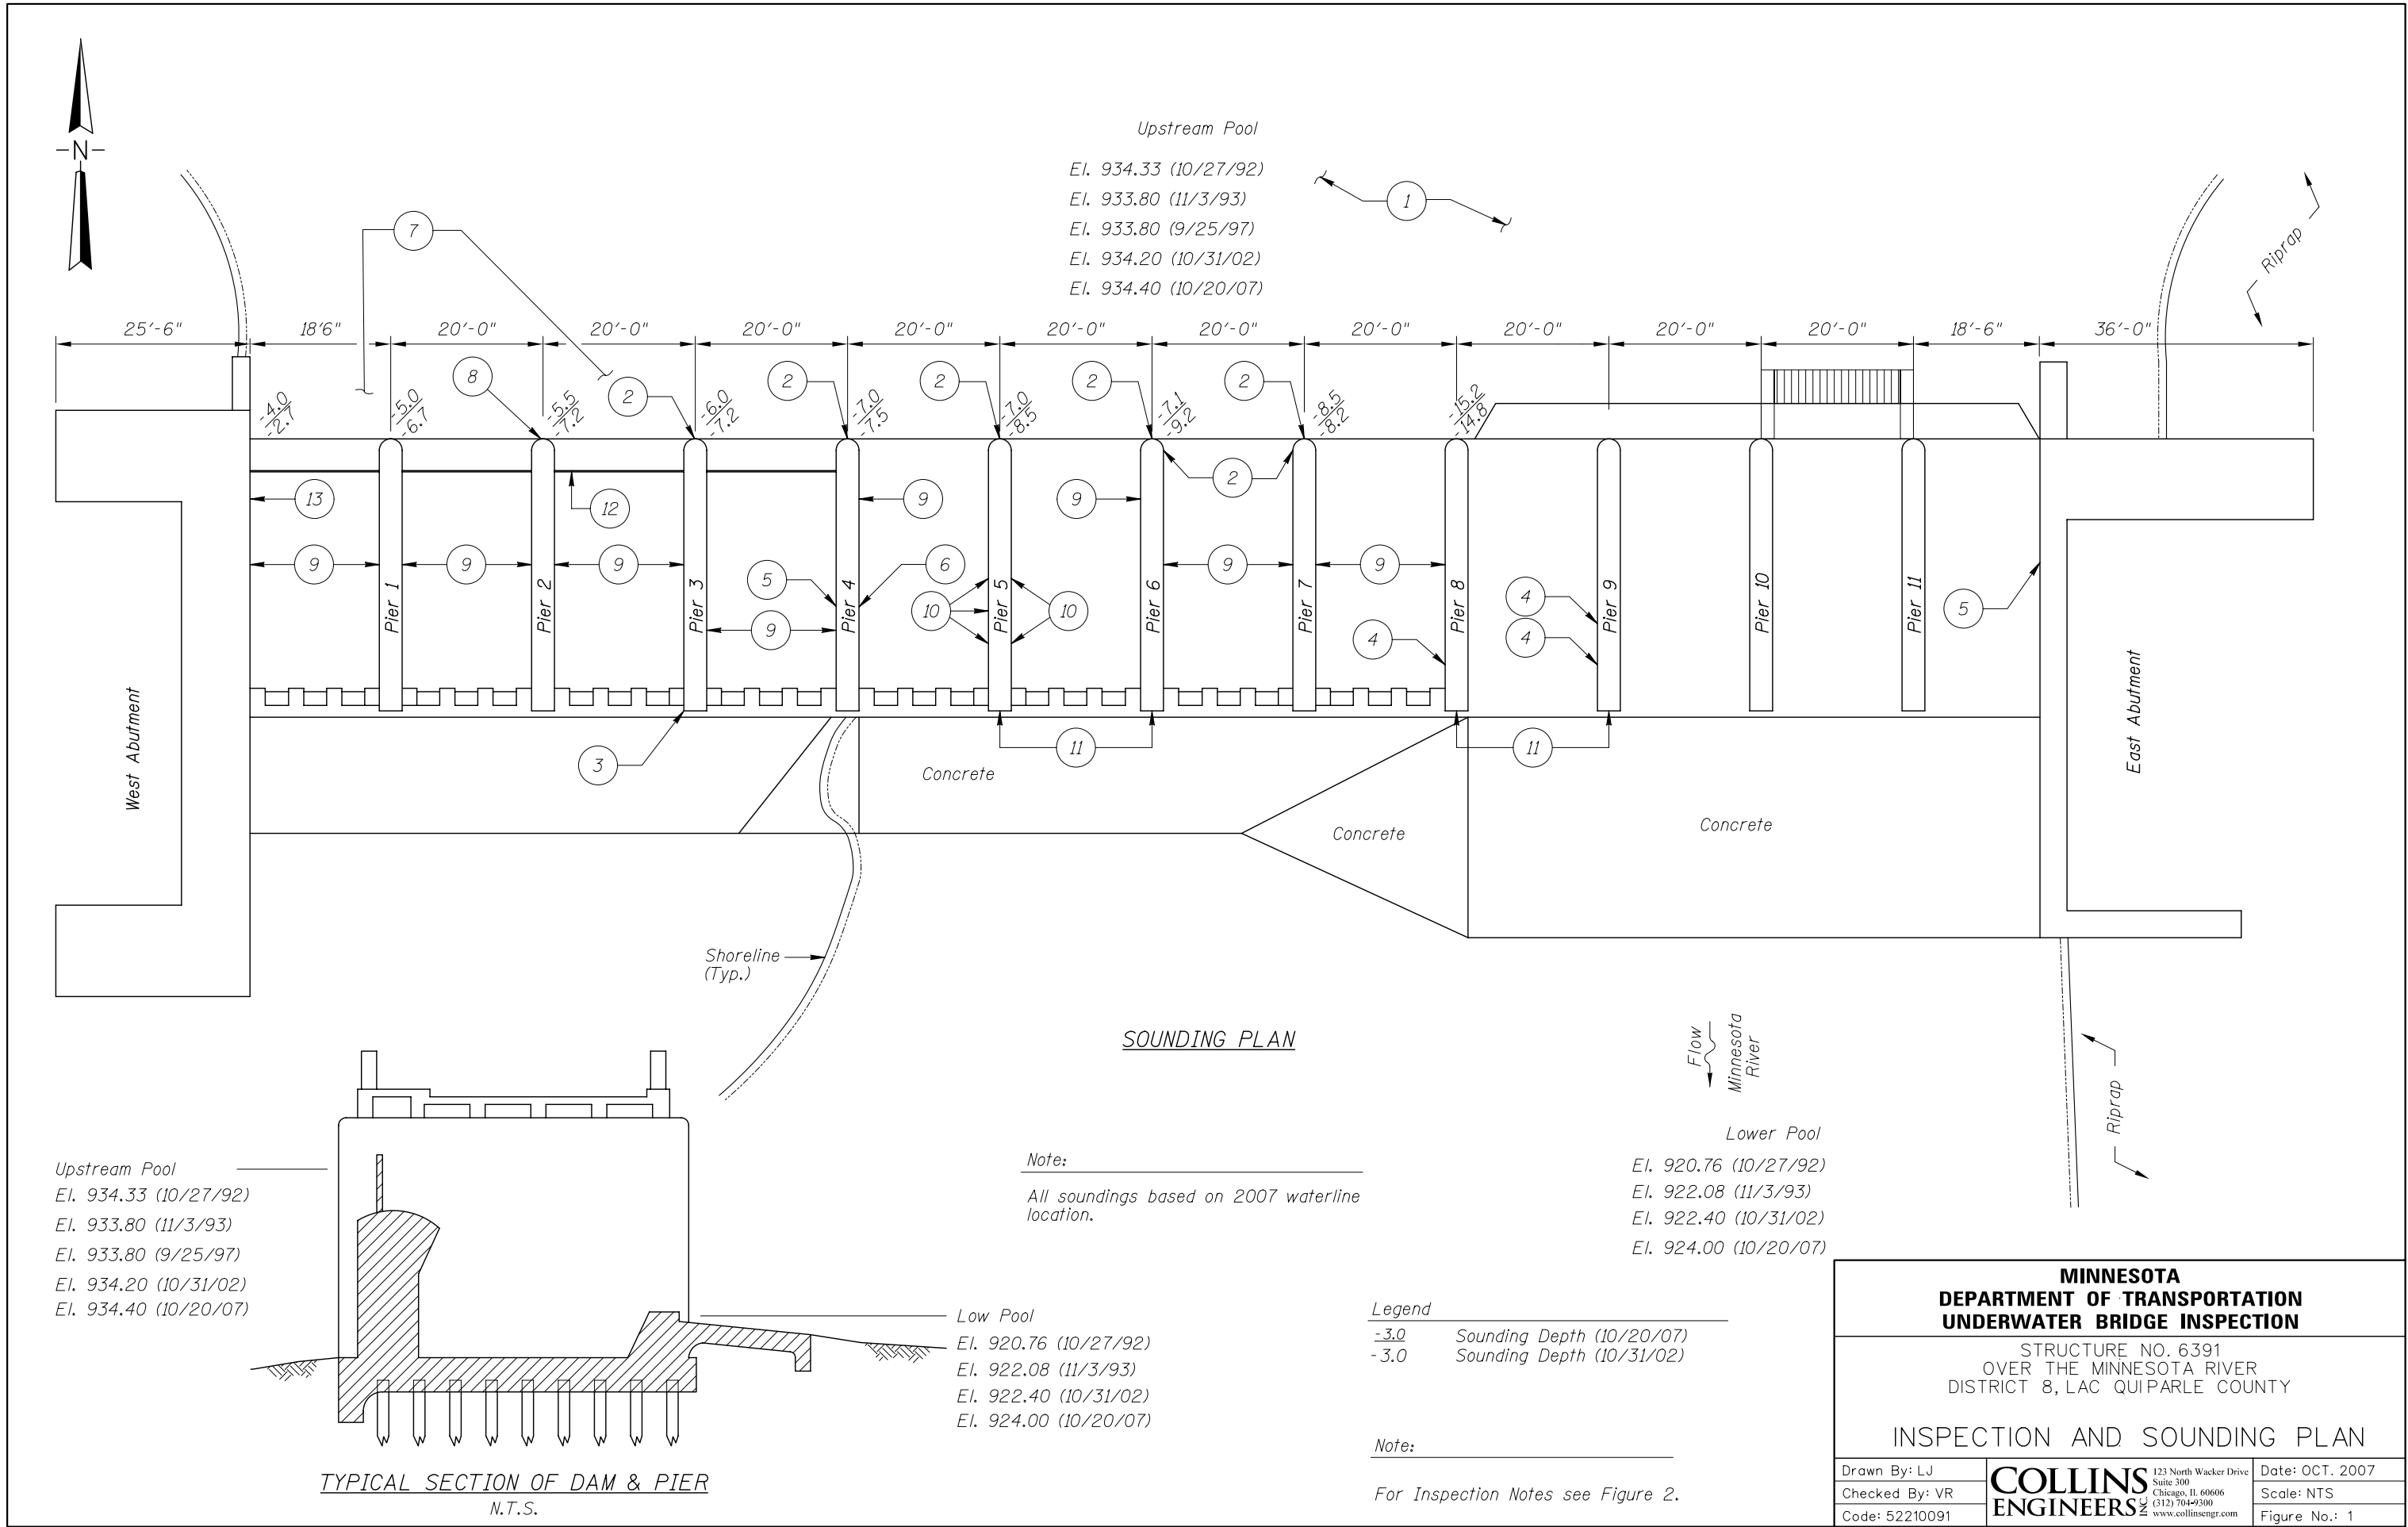
Figure No.: 2

- 1 The channel bottom material consisted of silt, sand, and cobbles with up to 6 inches of probe rod penetration.
- 2 Moderate to heavy scaling from 3 feet above the waterline to 5 feet below the waterline around the upstream nose with a maximum penetration of 3 inches and exposed reinforcing steel (less than 10% loss on exposed reinforcing) on Piers 4 and 5. Deterioration typically had up to 2 inches of penetration.

- 3 Spall located 6 inches above the concrete apron measuring 2 feet wide by 2 feet high with up to 3 inches of penetration and exposed reinforcing steel that exhibited less than 10% section loss.

- 4 Spall located 7 to 10 feet above the waterline with up to 3 inches of penetration and exposed reinforcing steel that exhibited less than 10% section loss.

- 5 A hairline vertical crack with efflorescence was observed extending from 8 feet above the waterline to the waterline. In addition, there were several small spalls around the crack typically 3 inches in diameter with exposed reinforcing steel that exhibited less than 10% section loss. (2002 note)

- 6 A hairline horizontal crack was observed at 1 foot above the concrete apron.
- 7 Timber debris was observed scattered on the channel bottom with pieces of drift up to 1 foot diameter.

- 8 Spall located from 1 foot above the waterline to 1 foot above the channel bottom with up to 5 inches of penetration and exposed reinforcing steel that exhibited less than 10% section loss.

- 9 Band of heavy scaling between 8 feet above the waterline and the waterline with typically up to 1/2 inch penetration and random areas of up to 1.5 inches of maximum penetration.

- 10 Scaling from waterline to 6 feet above waterline with penetrations up to 2 inches with exposed reinforcing steel was observed. Exposed reinforcing typically had up to 10% section loss.

- 11 Heavy scaling from 3 feet above to 3 feet below the waterline around the downstream nose with 3 inches of maximum penetration and exposed reinforcing steel that exhibited less than 10% section loss.

- 12 Spall located 1.5 foot above to 2.5 feet below the waterline with up to 3 inches of penetration and exposed reinforcing steel that exhibited less than 10% section loss.

- 13 Up to 1/16 inch vertical crack with oxidation and moisture from the apron slab extending upward.
